Our Four Properties

Building Condition Assessments

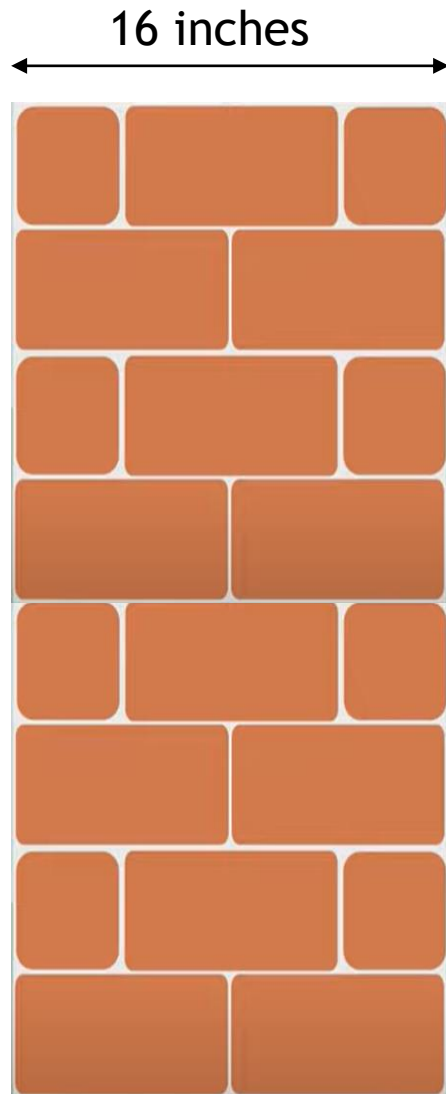
Load Bearing Brick Walls

- Load bearing brick wall construction - brick parged on three sides
- In general - cladding, glazing and exterior doors in poor to very poor to failed condition
- Emergency, stop gap repairs to secure the walls undertaken in 2003 with a recommendation to undertake substantial repairs in the short term - no repairs have been done since that time
- There is significant water ingress is continuing and causing further deterioration
- Extensive cracking in brick walls and debonding, cracking and spalling of parged walls
- Both CMEL and Campbell Comeau Engineering (Structural Eng) recommend extensive repairs that are required in immediate term

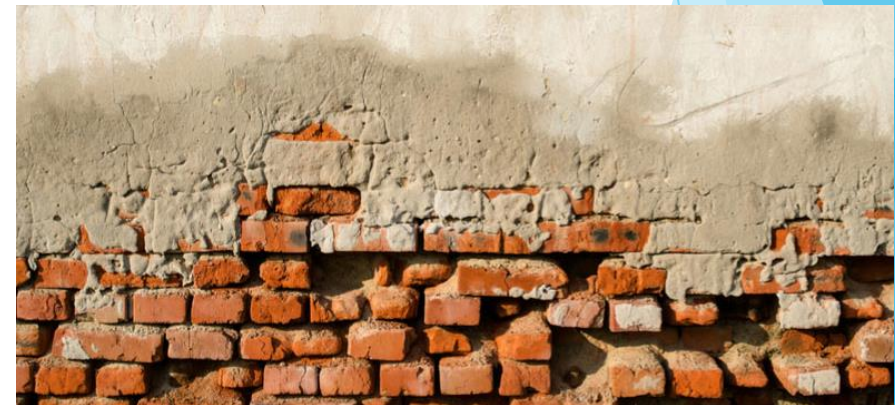
Parging Weathered Brick

3. **The exterior clay brick walls have been parged with a cement stucco. The parging is damaged at a number of locations and requires replacement. In addition, damaged brick masonry can be observed at some of the locations where the parging is missing. There are also cracks present in the masonry walls which require repair.**

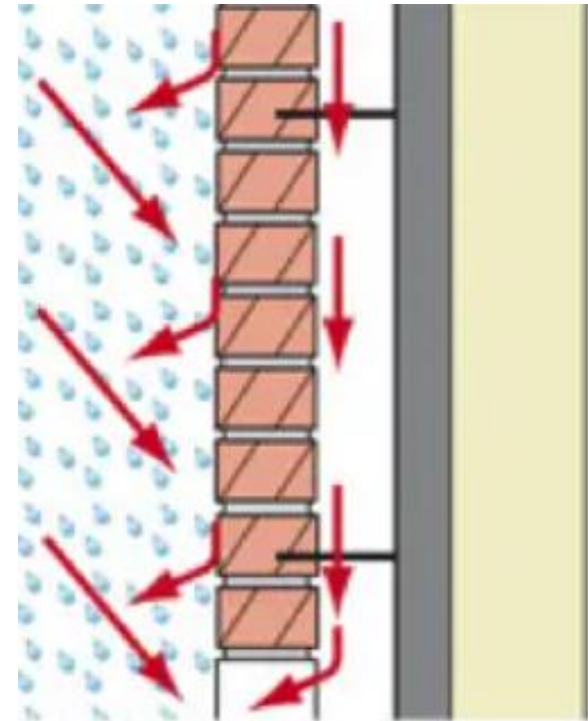
Rainscreen & Cavity

- Structural integrity of concrete wall (and thus the stone veneer) compromised due to insufficient ties to concrete superstructure
- The galvanized ties that bind the stone cladding to the concrete block structure have rusted and deteriorated to a point where the cladding is unstable

3. **The exterior stone facing is connected to the concrete block walls with corrugated strip ties. At many locations these ties were found to be corroded and their useful life has been consumed.**

- There is significant water ingress is continuing and causing further deterioration
- Restoration of the exterior walls will require removal and refastening of the exterior stone cladding to the concrete block and superstructure using new ties.
