Our Four Properties

Building Condition Assessments

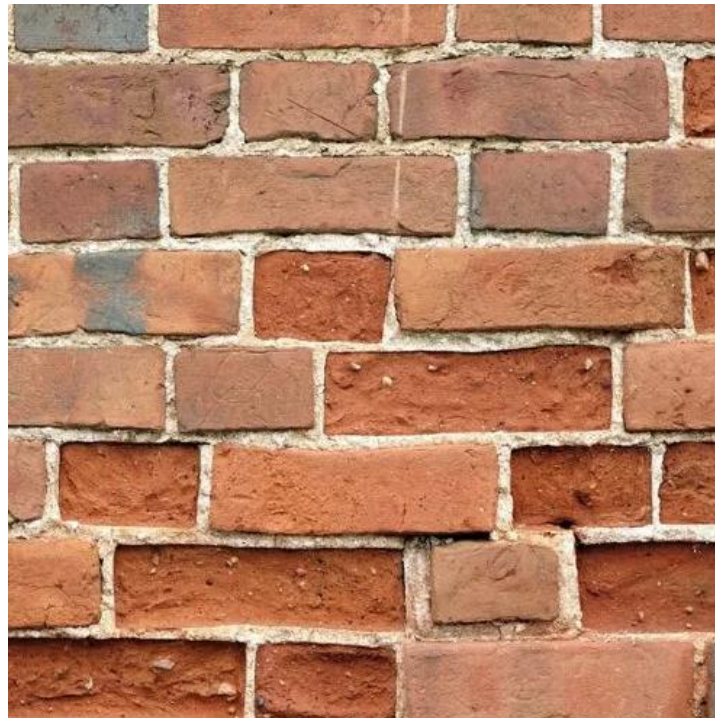
Weathered Brick and Mortar

Parging Weathered Brick

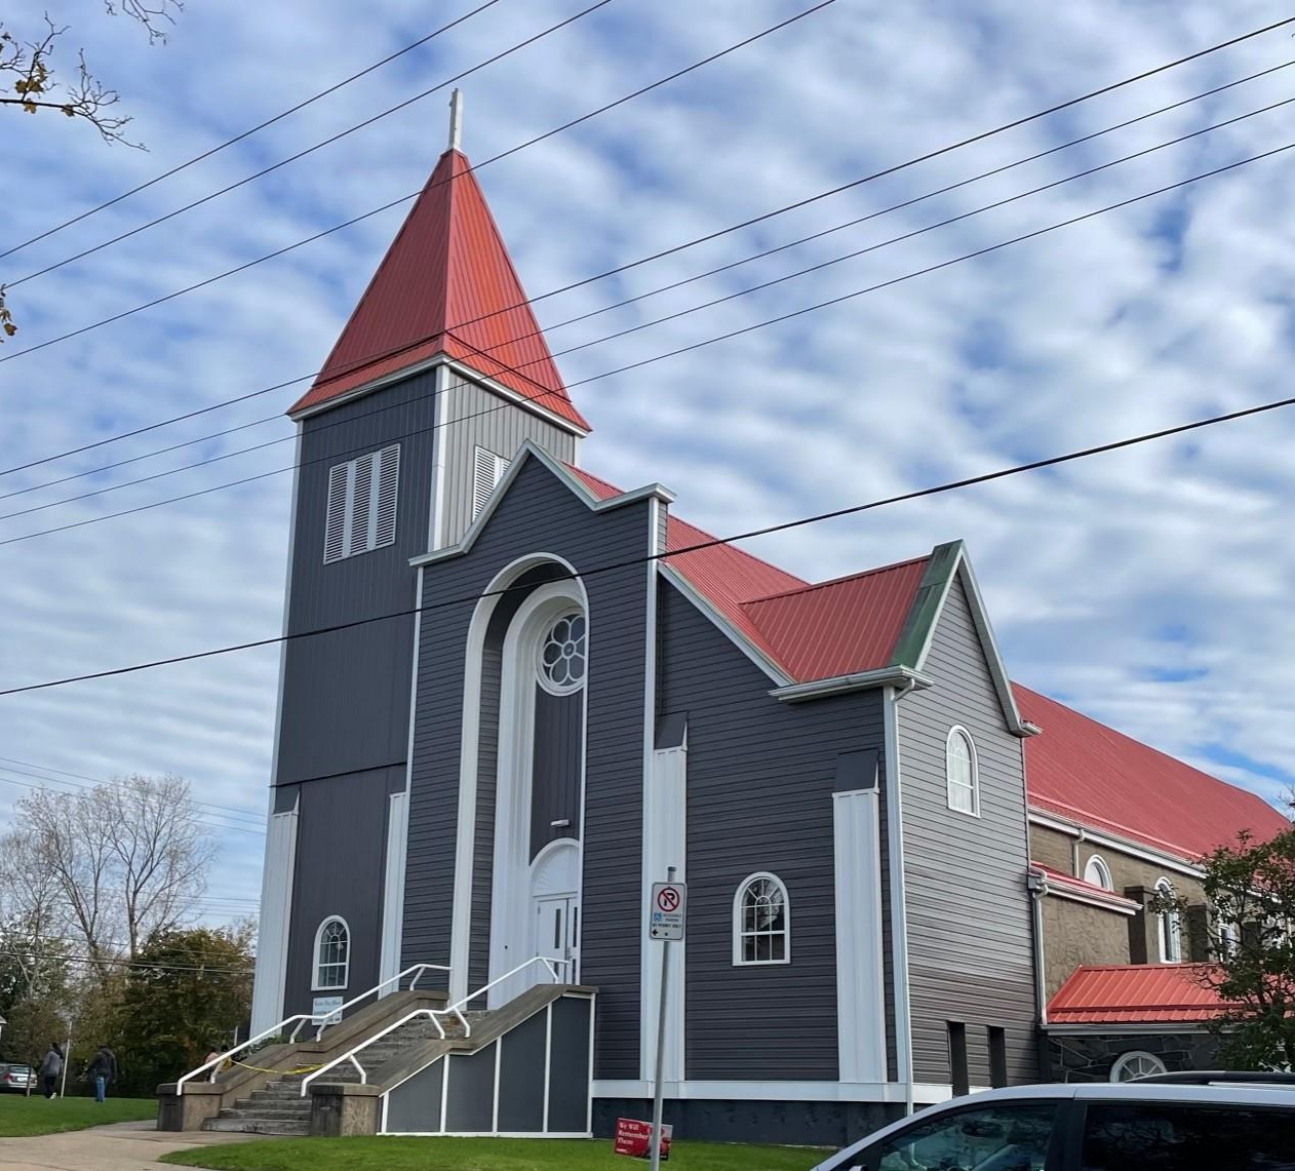
St. Stephen

- Relatively new roofing
- Roofing is metal and new asphalt - good to very good condition

- Stone and parged cladding on all buildings in good condition
- Minor damage/deterioration of mortar observed - requiring cyclical repointing
- Vinyl siding on rectory/garage longer term replacement required

- Windows in good condition throughout
- Glass block glazing will require replacement in the short term
- Main and secondary doors varied condition - good to poor - phased replacement over time
- Wood deck in need of replacement in short term

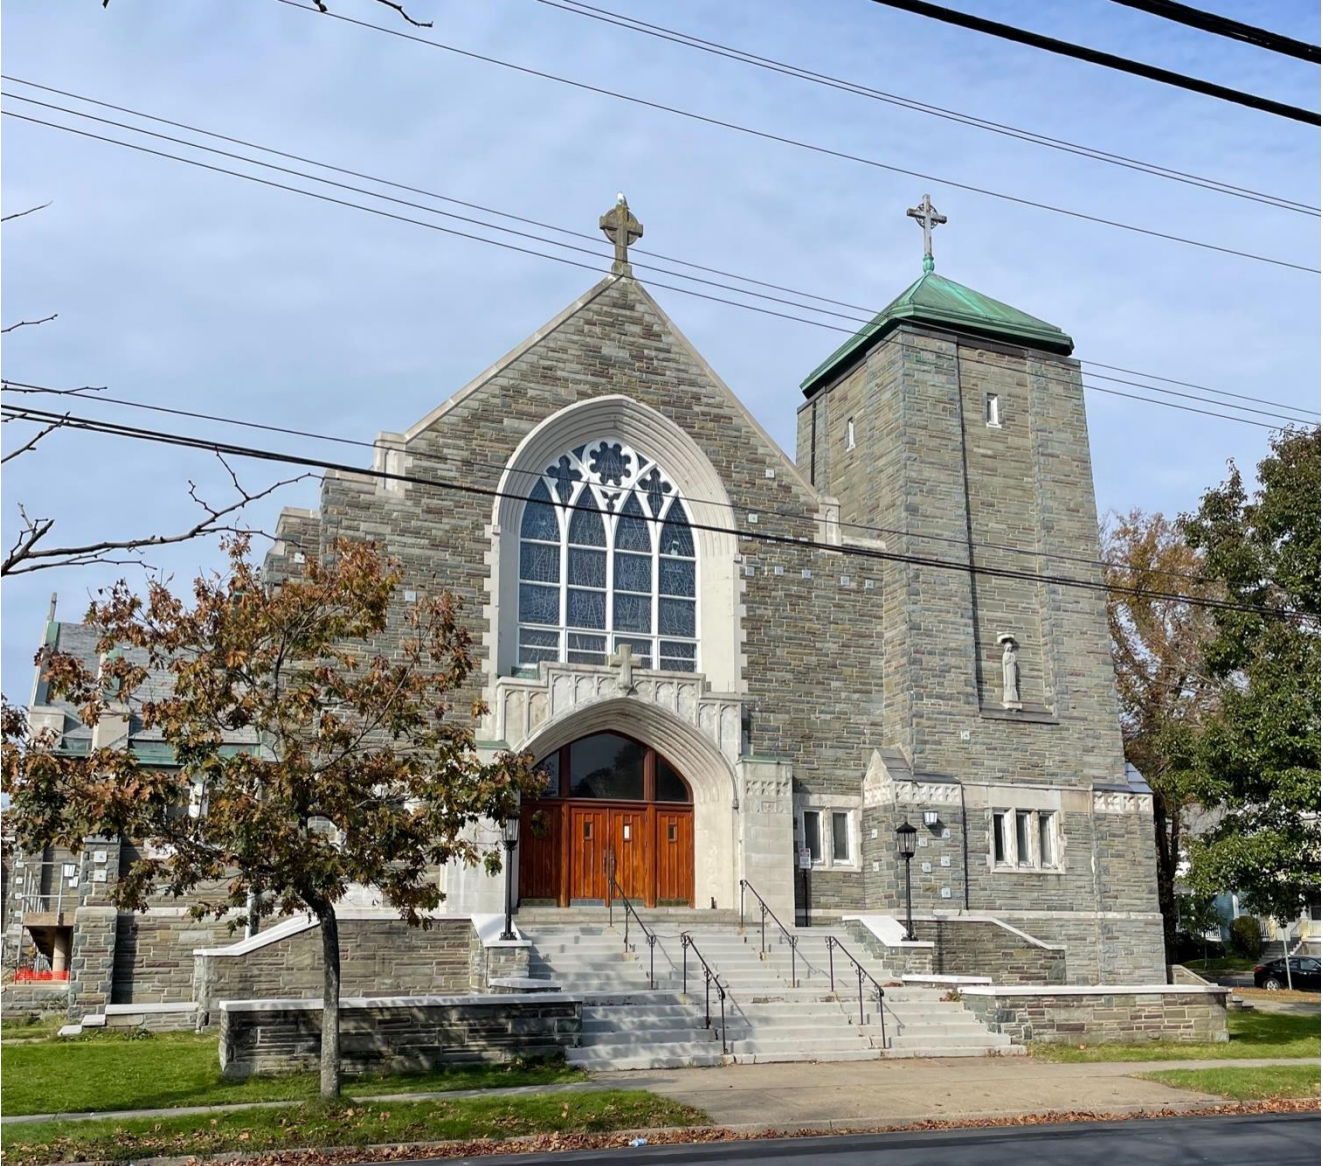
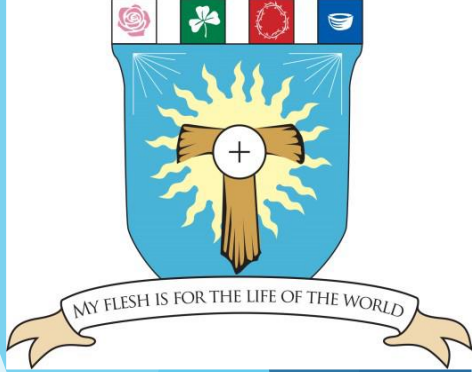
St. Theresa

- Main roof in generally good condition - no leaks but some deterioration near ridgeline and in valleys - repairs required
- Copper roofs and trim - good condition
- Lower asphalt roofs will require replacement

- Exterior cladding and exterior structures are in very poor to failed condition.
- Concrete accents above the entrances are in poor condition
- Throughout the exterior, the mortar is in failed condition

- Structural integrity of concrete wall (and thus the stone veneer) compromised due to insufficient ties to concrete superstructure
- The galvanized ties that bind the stone cladding to the concrete block structure have rusted and deteriorated to a point where the cladding is unstable
